# **Durability evaluation of protection coatings on water-wall tubes of low-emission boilers**

**Purpose:** of the paper is presentation of diagnostic research on durability of protection coatings on water-wall tubes in low-emission boilers.

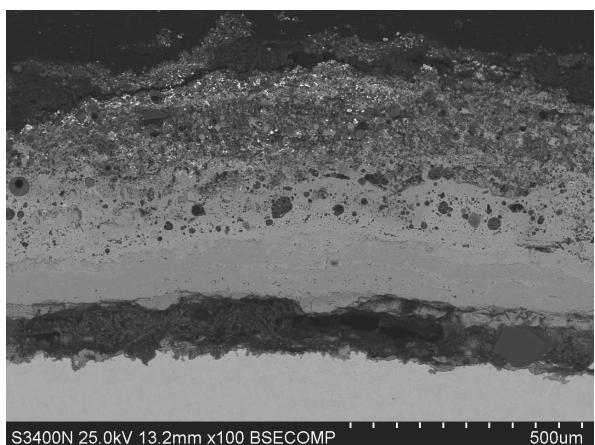
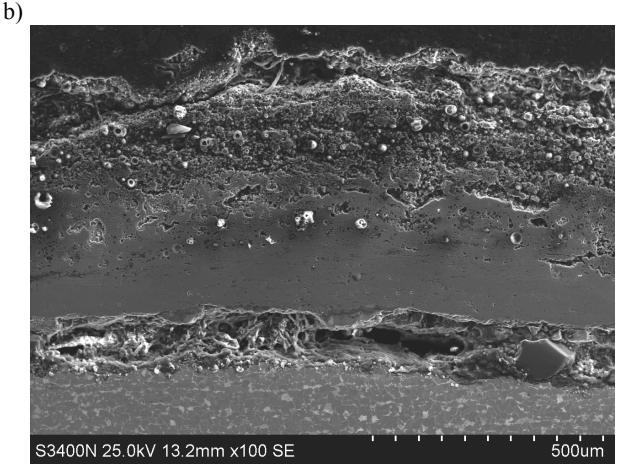
Example of morphology of scale present on the surface of the water-wall pipes (without a protection coating) working in a low emission boiler is shown in Fig. 1. Thickness of the scale is larger in relation to the scaling occurring in classic combustion boilers, in this case is about 500  $\mu$ m. Scale consists of two layers – the interior and exterior. The inner layer is composed of iron oxides (magnetite and hematite) and iron sulfides, is compact but weakly bound to the substrate and brittle. On the border between the scale and the steel elevated concentration of chlorine is observed. The

outer layer is porous and outside the iron oxides contains large amounts of alkali metals (Na, K, Ca), and aluminium, silicon, magnesium, titanium and sulfur. In the case of co-firing biomass in the outer layer may be a large amount of lead in the form of pure lead precipitates.

Fig. 1. Morphology of a scale on outer surface of a water-wall tube  $\emptyset$  57x5.0 mm (without a protection coating). Longitudinal cross-section, SEM detector: a) BSE, b) SE

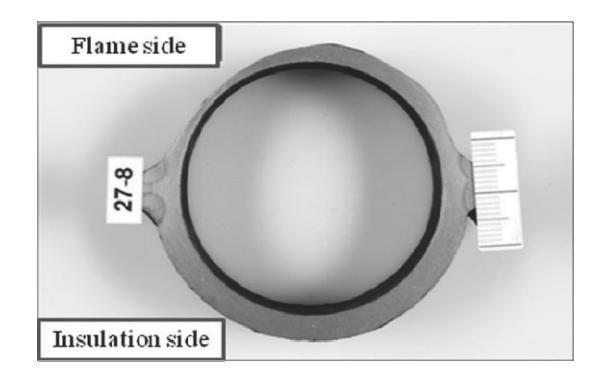
Fig. 2. Macrostructure of a cross-section of the water-wall tube  $\emptyset$  57x5.0 mm (without a protection coating)

The described scale is the result of the synergistic effects of hot corrosion along with low-oxygen and sulfur corrosion, and does not protect against the destruction (wastage) of the pipe. The result is a rapid thinning of the pipe wall from the side of flame impact (Fig. 2). The final stage of a wall thinning is decohesion (open up) of a pipe, as a result of exceeding the allowable stresses.

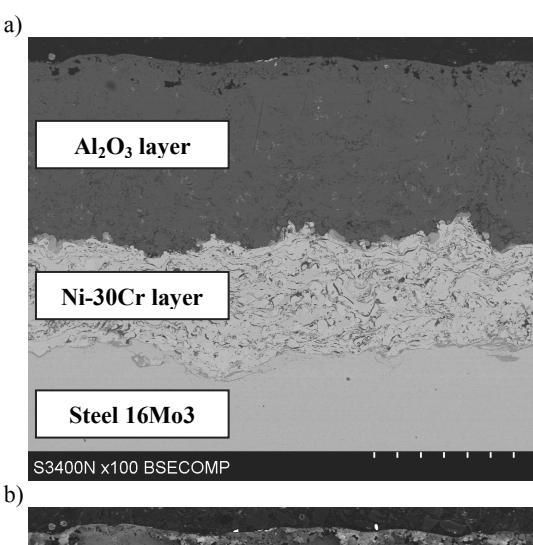
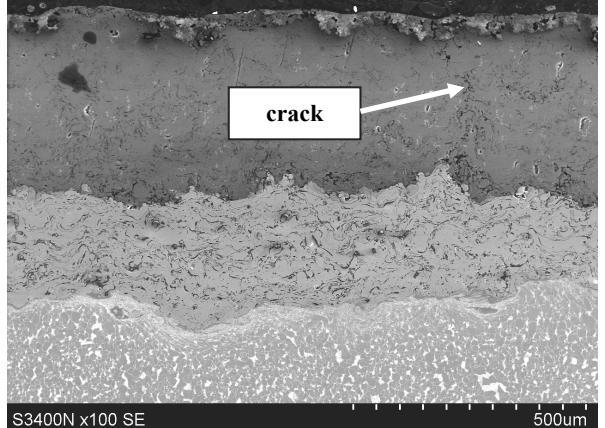
Morphology of the coating after one year of operation in the low-NO<sub>x</sub> emission boiler is shown in Fig. 3. On the outer surface of the tube there is a two-layer coating with a total thickness of approximately 650  $\mu$ m. The inner layer was applied with the Ni-30Cr alloy, has 250  $\mu$ m in thickness and a very good connection with the pipe base material. The outer layer was applied with aluminium oxide Al<sub>2</sub>O<sub>3</sub>, and has a thickness of about 400  $\mu$ m. The outer ceramic layer of the coating has only a slight degradation caused by a flame and exhaust gas at high temperature, but there was observed pores and cracks extending through the whole thickness of the ceramic layer [13].

Fig. 3. Morphology of the ceramic protection coating on a surface of the water-wall tube  $\emptyset$  57x5.0 mm, after one year of operation. Longitudinal cross-section, SEM detector: a) BSE, b) SE

Double-layer thermally sprayed coating, with outer ceramic layer, fulfilled its protective role against flame, low oxygen and sulfur corrosion, by year of operation of the water-walls. However, investigations have shown that in  $Al_2O_3$  layer pores and cracks perpendicular to the tube surface are presented. The presence of pores is due to the thermal spray coating process and it is typical for this process. Cracks are due to cyclical changes in temperature and associated thermal stress, and the natural fragility of ceramic layers. It should be noted that thickness of ceramic layer is large (400  $\mu$ m) which contribute to increase of coatings brittleness. Then, cracks and pores allowed a transport of oxygen, sulfur, and chlorine, through the coating to the base metal, and the formation of the oxide layer with iron sulfides beneath the coating. Increasing the coating layer of iron oxides and sulfides resulted in the gradual chipping of the coating, which after two

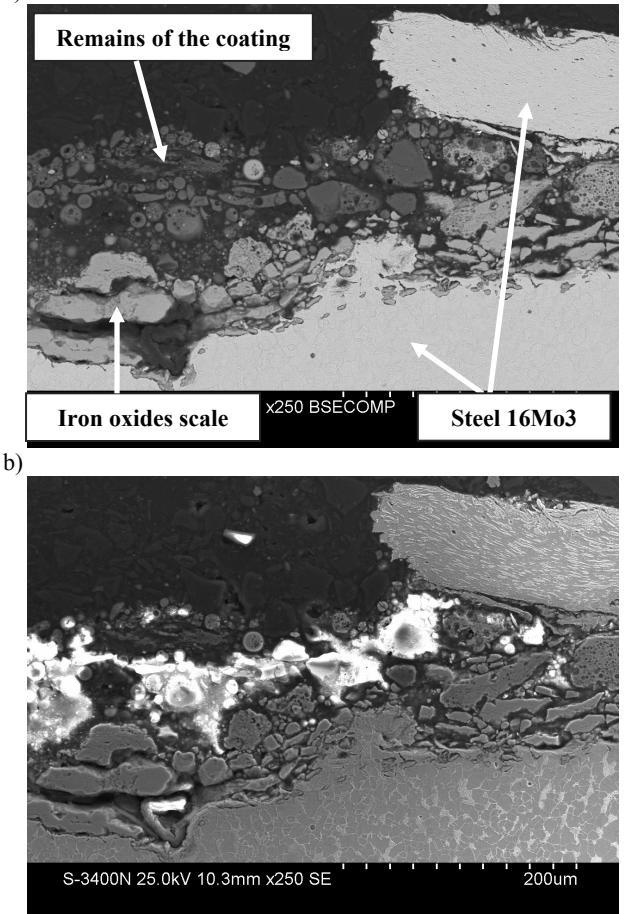
Metallographic examination after two years of operation showed that the coating was almost completely degraded, and on the outer surface of the water-wall tubes, there are only remains of the sprayed ceramic coating (Fig. 4). On the outer surfaces of pipes characteristic scale for sub-stoichiometric combustion appeared. Elevated concentrations of aluminium in the scale may indicate that it was used a ceramic layer.

Fig. 4. Morphology of the ceramic protection coating on a surface of the water-wall tube  $\emptyset$  57x5.0 mm, after two years of operation. Longitudinal cross-section, SEM detector: a) BSE, b) SE

years of operation resulted in the almost complete destruction of the protective coating. The intermediate layer of Ni-30Cr alloy was completely destroyed probably by sulfur corrosion and intensive development of nickel and chromium sulfides. There was, however, no remnants of the intermediate layer, which indicates its low resistance to flame corrosion and exhaust in lowemission boilers.

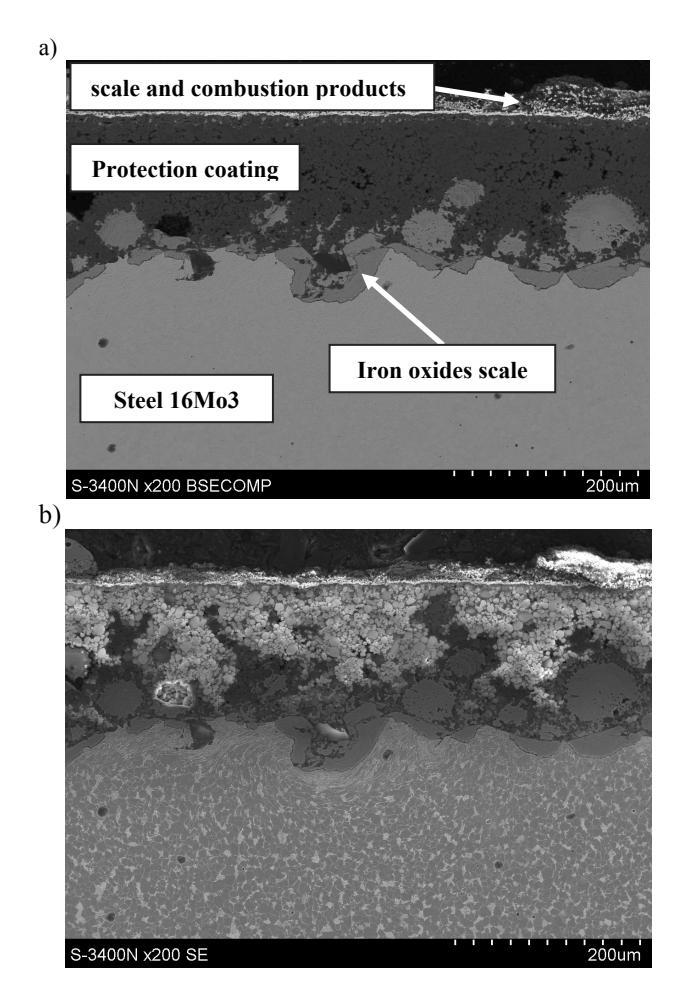
After a one year of operation on the outer surface of the tube in the surface layer it was revealed the presence of the following layers (Fig. 5), starting from the pipe base metal to the surface:

the iron oxides scale layer with a thickness of about 70 μm, with iron sulfides (local concentration of sulfur in the scale reaches up to 22% by weight),

- porous, two-layer protective coating with a thickness of approximately 140 µm – there was no damage to the coating in the form of voids, cracks and pitting corrosion,
- a layer of a scale and combustion products with thickness of approximately 20 μm, which is composed of iron oxides and contains large amount of aluminium, silicon, sulfur, lead, and a small amount of phosphorus, potassium and calcium.

There was no corrosion damage to the applied coating after one year in service, but only slight thinning of the pipe wall from the heated side.

Fig. 5. Morphology of the painted protection coating on a surface of the water-wall tube  $\emptyset$  57x5.0 mm, after one year of operation. Longitudinal cross-section, SEM detector: a) BSE, b) SE

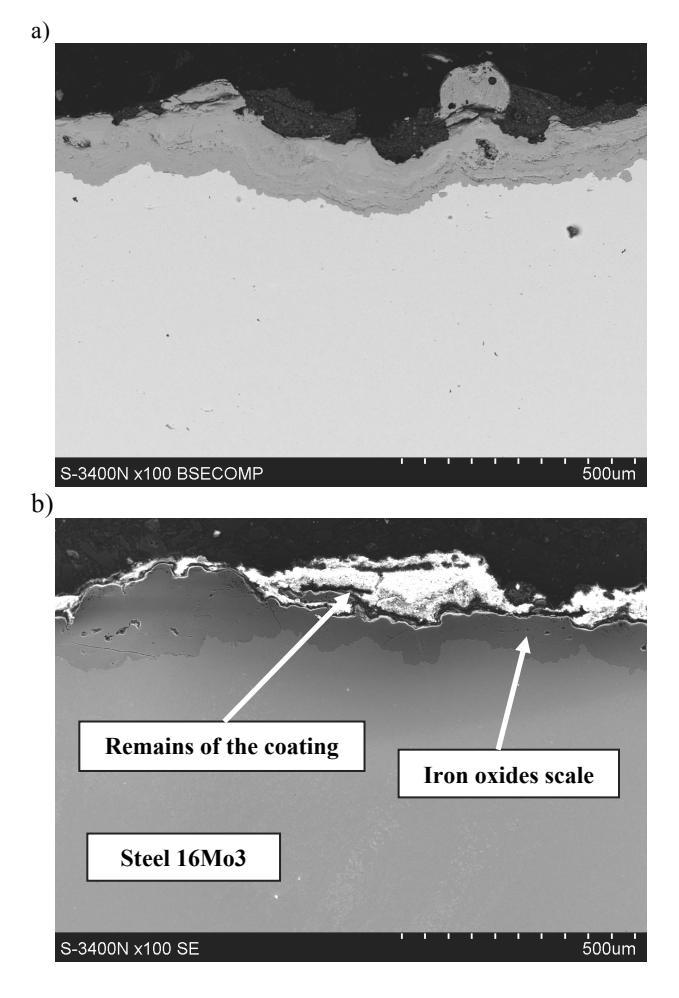
Metallographic examination after two years of operation showed that on the outer surface of the pipe the protective coating was almost completely degraded and destroyed. There were only remains of the protective coating, and relatively thick (150-200  $\mu$ m) layer of iron oxides and sulfides (Fig. 6). Increasing layer of iron oxides and sulfides slowly "surpassed" porous protective layer, thereby leading to its destruction.

Fig. 6. Morphology of the painted protection coating on a surface of the water-wall tube  $\emptyset$  57x5.0 mm, after two years of operation. Longitudinal cross-section, SEM detector: a) BSE, b) SE

Hybrid protective coating applied by painted technology has fulfilled its task by one year of operation in the combustion chamber. Evidence of the behaviour is a continuous coating of uniform thickness, and only a slight thinning of the pipe wall from the flame side. The formation of iron oxides scale on the outer surface of the coating shows that the coating was not fully dense (is permeable for ions), and the diffusion of iron atoms/ions throughout the coating was observed. As described in section 4, the hybrid painted coating is permeable, and is designed to only slow down the process of diffusion. At the same time the layer of iron oxides and sulfides was growing under the protection coating, as a result of incomplete dense of the coating and diffusion of oxygen and sulfur, which confirm an increase of the scale thickness from 70 µm after one year of operation to 200 µm after two years. The growing layers of iron oxides and sulfides above and below the protective coating resulted in "surpassing" the coating (trespassing of scale into the coating), which after two years of operation has led to the almost total destruction of the protective coating by spalling (peeling). Not be ruled out that the coating was also destroyed by erosion as a result of direct exposure to the burner (flame and exhaust) and the air flow from the blower.
